# Evaluation Report

# 646

## Case IH 8380 Mower Conditioner

## CASE IH 8380 MOWER CONDITIONER

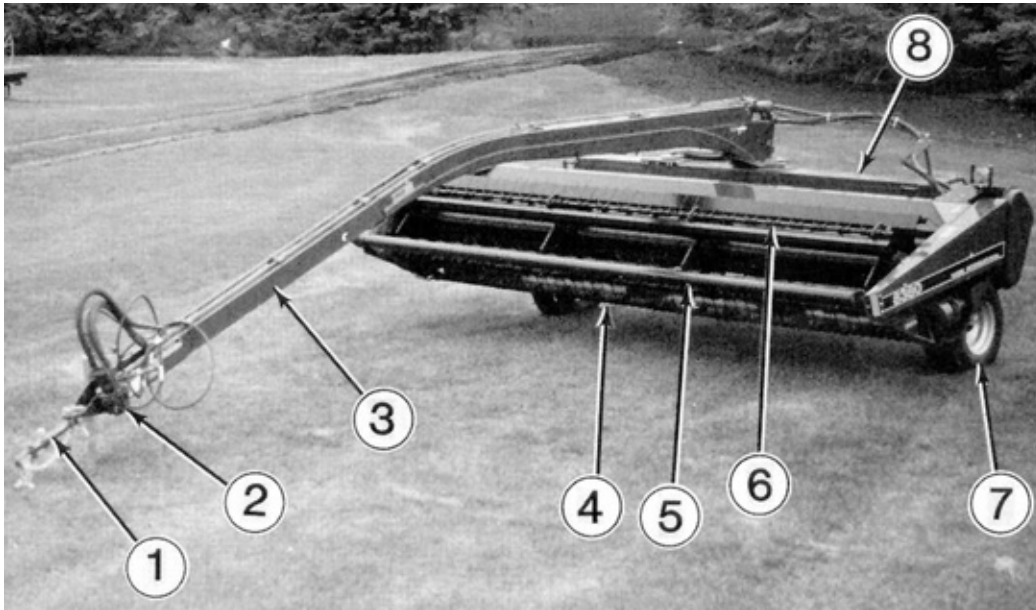
**FIGURE 1.** Case IH 8380 Mower Conditioner: (1) Drawbar Extension, (2) Hydraulic Pump, (3) Swing Tongue, (4) Cutterbar, (5) Push Bar, (6) Bat Reel, (7) Floatation Tires, (8) Main Frame.

The height of the machine is hydraulically adjustable to permit ease of conversion from field to transport position. It utilizes mechanical transport locks. Detailed Specifications are given in APPENDIX I, while FIGURE 1 shows the location of major components.

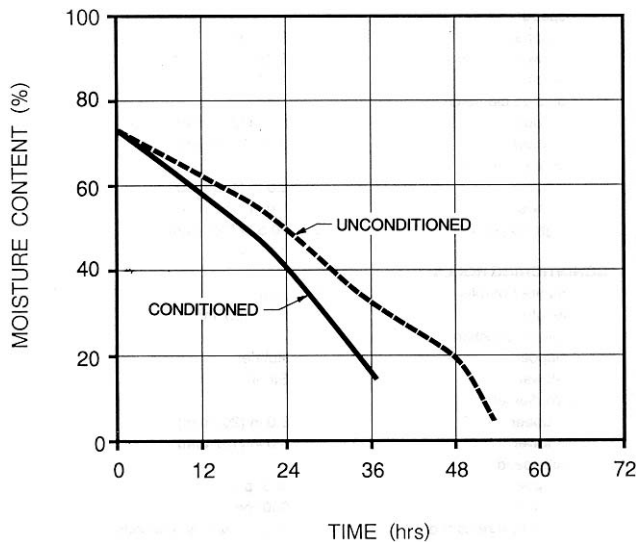
The difference in drying or curing time between a conditioned crop and an unconditioned crop is shown in FIGURE 2. The tests were carried out in the same crop on the same days in parallel windrows. Other conditions that affect curing time are stubble height, ambient temperature and wind velocity. Generally the advantage of a conditioned crop is one-half to one day advance baling.

FIGURE 2. The Effect of Conditioning in Alfalfa at 1.2 ton/ac (2.6 t/ha) for the Case IH 8380.

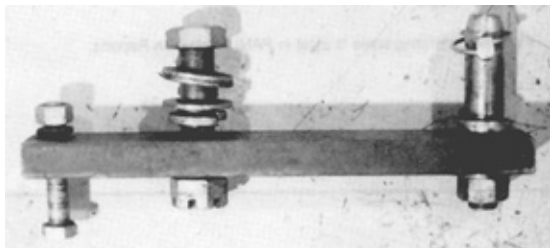
**Hitching:** Ease of hitching was considered good. The Case IH 8380 was equipped with a drawbar extension that had to be bolted to the tractor drawbar before the mower conditioner could be attached. Once the hitch extension was attached, the mower conditioner hitch was lowered onto the hitch extension pin (FIGURE 3).

FIGURE 3. Drawbar Extension.

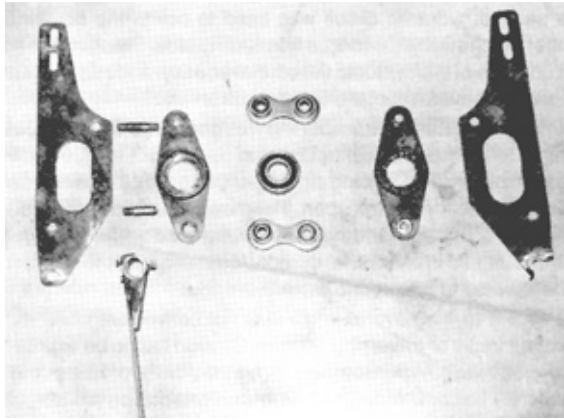
**Sway Bar:** At 106 hours the lower link pin in the right sway bar failed (FIGURE 4). Damage was confined to the sway bar assembly and the sickle head on the right knife bar. The sway bar was replaced as a unit. The sickle head was also replaced.

FIGURE 4. Failed Knife Drive Mechanism.

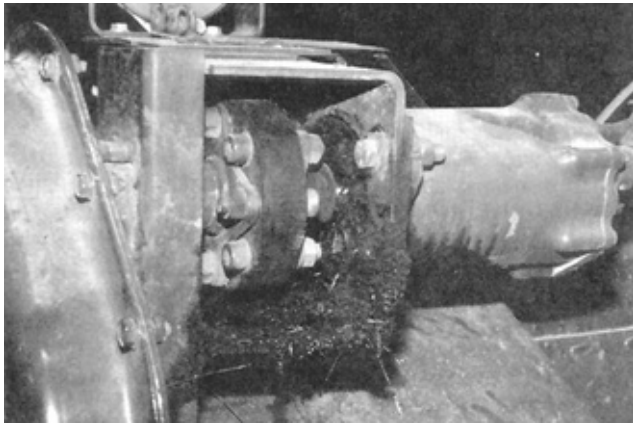
**Hydraulic Motor:** The oil seal on the output shaft leaked a small quantity of oil throughout the duration of the test. No attempt to repair was made (FIGURE 5).

FIGURE 5. Leaking Oil Seal on Hydraulic Motor.
